*Platinum Restoration Returns a Historic Home to Its Splendor*

2013 PHOENIX AWARD  
*for* INNOVATION IN RECONSTRUCTION

*Platinum Restoration Returns a Fire-Damaged Historic Home to Its Splendor*

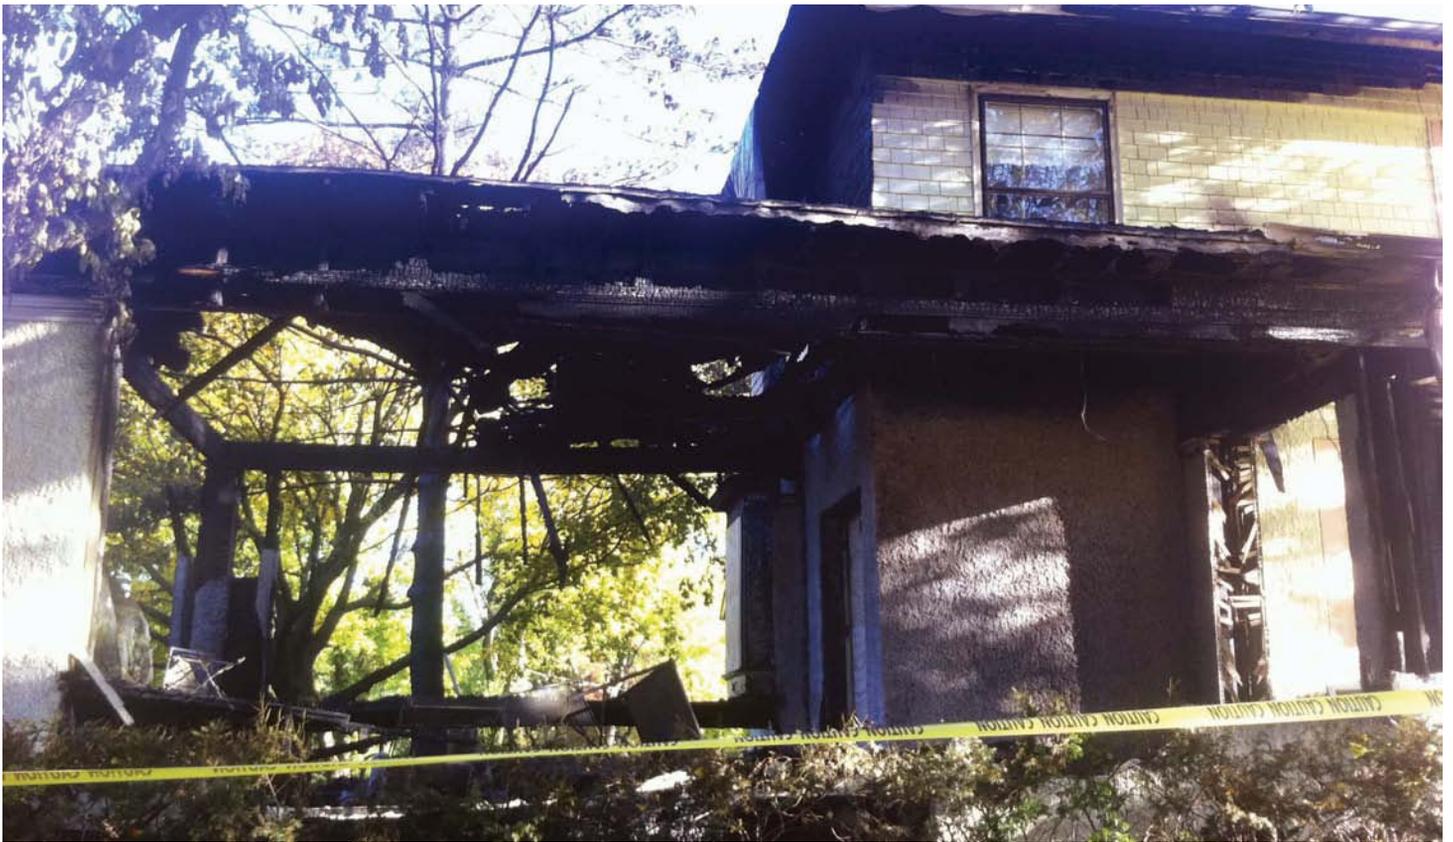
The fire started in the porch, which had to be demolished.

Then there was the construction of the porch. Unlike other areas of the home, Platinum had a difficult time measuring the porch because it was gutted during the fire. Engineers and carpenters followed the old foundation and outline of the house for reconstruction. They demolished the porch and rebuilt it using a poured foundation and glued laminated timber (Glulam) supports to keep its original appearance and strengthen the structure. The custom-built screens and exterior shades were strengthened as well.

"The heart of this house was the porch," explained Tom Barr, president of Platinum Restoration. "It had been almost completely decimated by fire. It was difficult to get the exact dimensions of the space and the intricate details of the trim and door parts. Photos were available but were not clear enough to get it exact. However the exterior trim was similar, and the homeowner's memory was invaluable."

The porch was originally built on a slight angle to allow water runoff from the roof to a small plaster swale through the porch wall and then into the garden. During reconstruction the Platinum team sanded, treated and primed the home's hardwood floors, so it was important for water not to damage the new floors. Workers took precautions and used a heavy-duty paint to ensure a good seal to the walls.

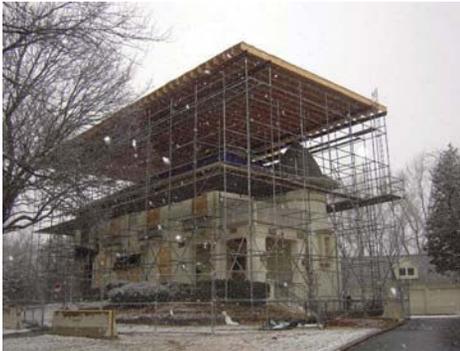
To quickly protect the structure from impending wintry Chicago weather, Platinum constructed a new roof to cover the old one until it could be rebuilt.

The company needed to be innovative with the roof reconstruction. It would normally take more than two weeks to remove the entire roof, eradicate the smoke odor and replace the structure. This was not an option because of weather conditions. Another constraint was waiting for the necessary lumber to be milled. Platinum took every step possible to safeguard the home by drying the structure and removing smoke odors without extensive encapsulation.

The company determined that the best way to salvage the rest of the 15-room home was to build a new roof over the old one. Commercial scaffolding spanned the entire second floor of the home, and multiple tarps were used to keep out water and snow. Expert plasterers, carpenters and woodworkers handcrafted windows, doors and exposed joists that tied into the home's framing and historic finishes. Many of the wood and studs used were milled to achieve an aged appearance. It took dozens of carpenters and more than 1,000 technician hours to complete the roof alone.

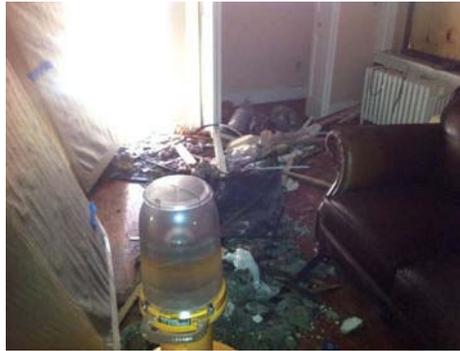
The walls, ceilings and floors in the master bedroom were damaged in the fire.

Platinum was able to clean and restore many of the walls and rebuilt most of the windows in the house. A number of plaster ceilings were replaced to prevent collapse. The team also cleaned and restored most of the doors and hardwood in the master bedroom and throughout much of the second floor.

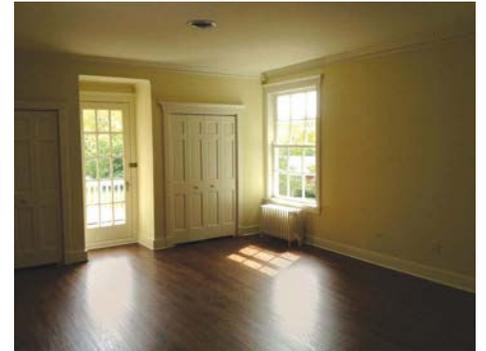
The reconstruction in the master bedroom is a good example of the thoughtful attention to detail that was carried out throughout the house.
